# **Oak Tree, Wells's Manzanita, and Creek Crossing Evaluations**

**Huasna Well Sites and Access Roads  
APN: 085-271-004; Lot 4  
E/2SW/4, SW/4SE/4, Sec. 30, T12N, R33W  
County of San Luis Obispo, CA**

**V. L. Holland, Ph.D.**

**12 March 2008**

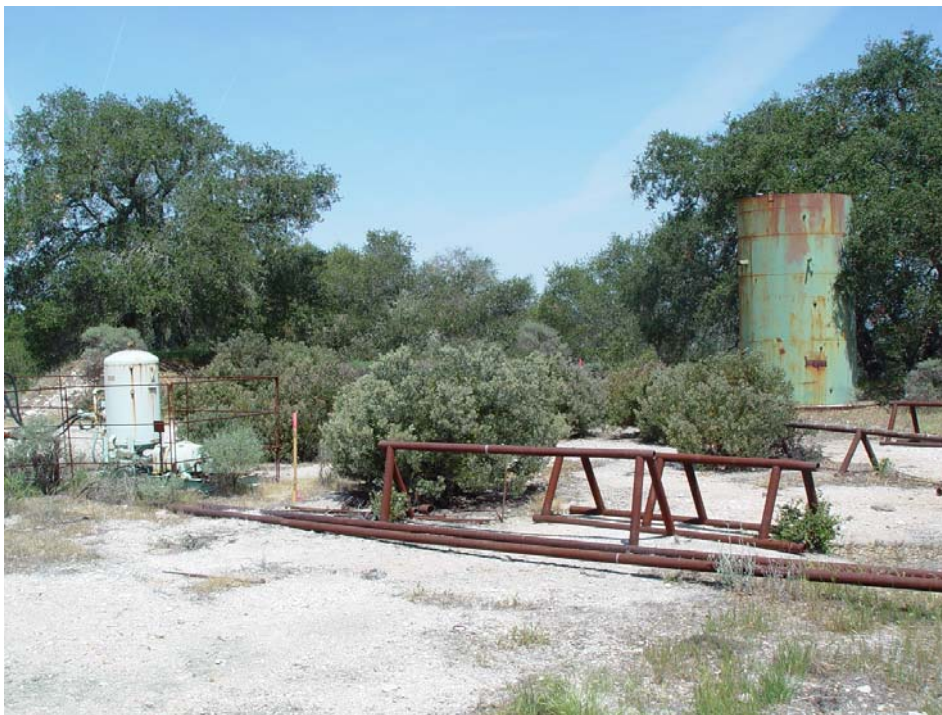
Results of our inventory show that there are 13 Wells's manzanitas on the upper well pad that will be removed as a result of the project. In addition, there are three manzanitas along the road to the upper well site. It is not clear whether these three shrubs will be affected by the project at this time. Wells's manzanitas varied in height from about 3 to 10 feet; however, the majority of the shrubs were 4 to 6 feet tall (Photo 1). The location and height of the Wells's manzanitas are shown in Appendix 1: Topographic Map Sheet 4 of 4, existing upper well site.

Photo 1. Upper well site showing the well developed Wells's manzanitas on the pad that will be removed as a result of the proposed project. Photo taken in May 2007.

A restoration and mitigation plan for the removal of Wells's manzanitas should be prepared by a qualified restoration botanist. Excelaron has asked me to prepare the plan for San Luis Obispo County approval and to start implementing the plan prior to clearing the upper well site pad. If this is acceptable to the County, I will proceed with preparation of the restoration plan.

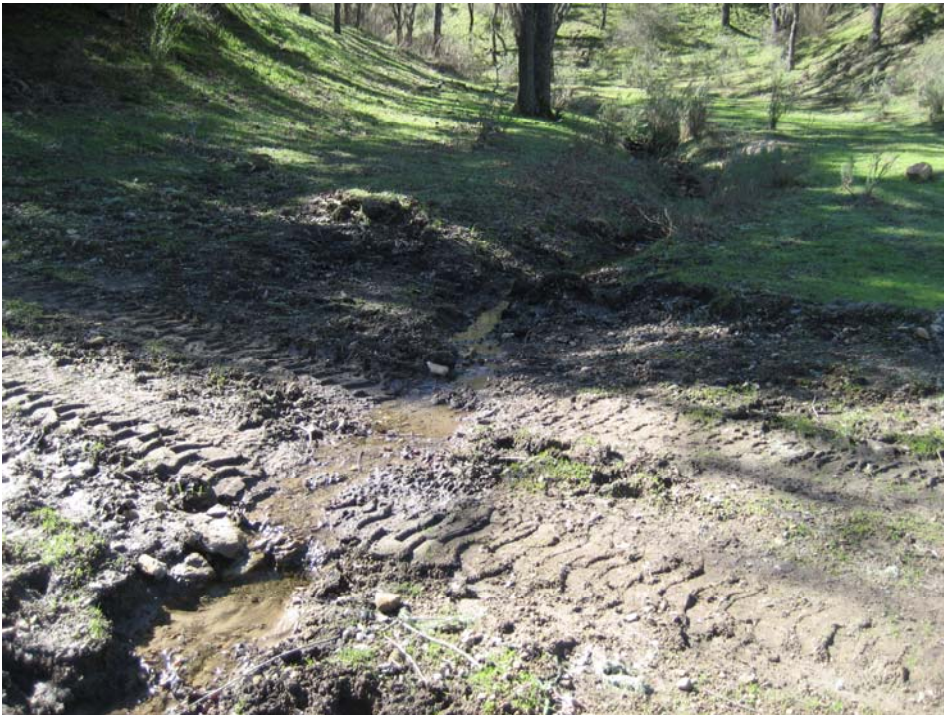
Two of the creek crossings (#1 and #2 on Figure 1 and shown in Photos 2 and 3) traverse very small drainages that had little water flow on February 29, 2008, which was shortly after a fairly heavy winter rain event. These creeks are small seasonal drainages that are vegetated by the typical grasses and forbs of the surrounding oak woodland understory. Where the creeks traverse the access road, the water mostly flows in small channels over the road and then into the undisturbed channel downstream. No wetland vegetation was found along these creeks within 10 feet of the road sides.

Photo 2. Photo showing creek crossing #1 on February 29, 2008 shortly after the early winter rains. The vegetation along the creek is grassland that forms the oak woodland understory in this area. No wetland indicator species were found.

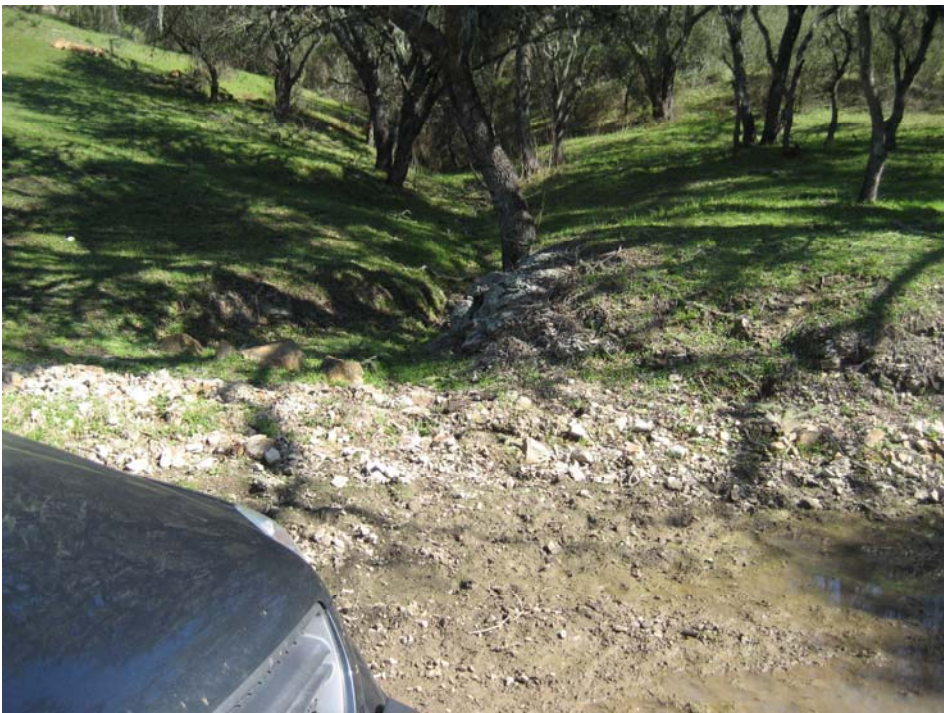
Photo 3. Photo showing creek crossing #2 on February 29, 2008 shortly after the early winter rains. The vegetation along the creek is grassland that forms the oak woodland understory in this area. No wetland indicator species were found.

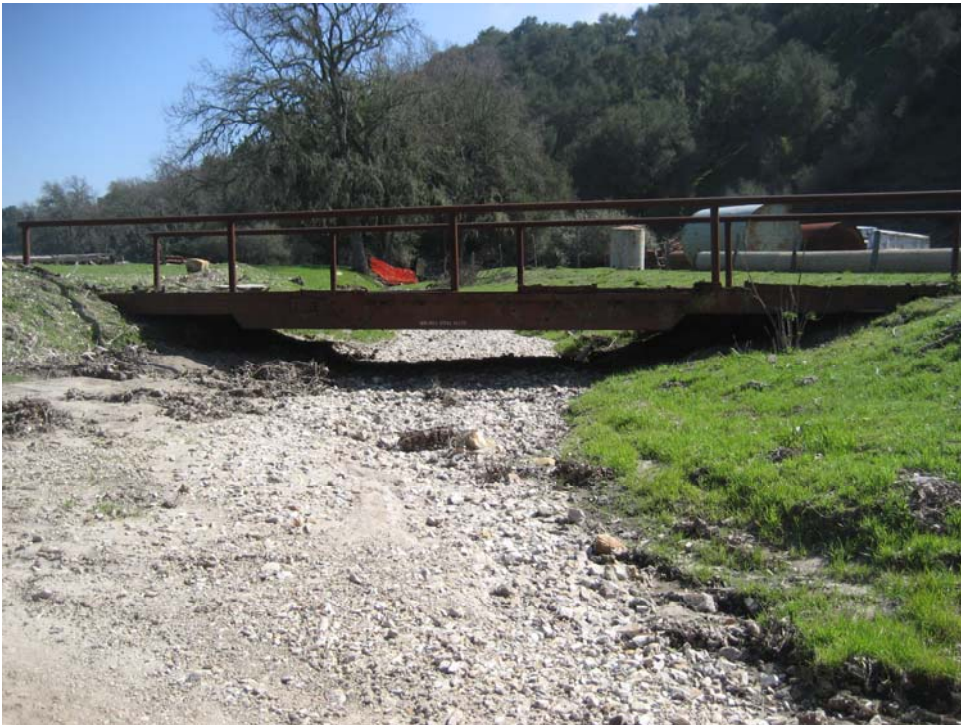
Creek crossing #3 traverses a well developed, seasonal creek channel that consists of a barren, sandy-rocky channel with no surface water for much of the year (Figure 2; Photo 4). However, the creek does have significant water flow during some of the heavy winter rains. During these periods, the bridge will be used to traverse the creek. The rapidly flowing water scours the channel removing any invasive plants that may have become established during the dry season. As a result, no vegetation was found in the creek channel during our survey except for a few small herbs that are part of the waif flora that became established when the channel was dry. The vegetation along the banks of the creek is grassland typical of the grasslands adjacent to the creek. No wetland vegetation was found during our surveys.

Photo 4. Photo of creek crossing #3 showing its bridge and the creek channel on February 29, 2008 shortly after the early winter rains. The creek channel has been scoured by the rapid water flow and is almost devoid of vegetation. The adjacent grassland vegetation extends along the creek bank in this area. No wetland indicator species were found.
